MicroROV Technology Helps in *USS Arizona* Preservation

By: Bob Christ

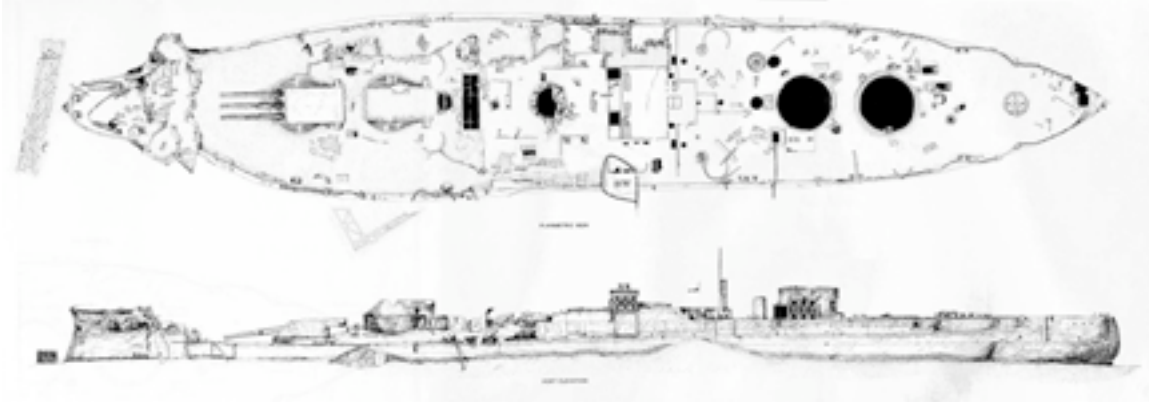
Recent detailed maritime archeological assessments and documentation reveals the *Arizona* to be substantially intact, lying at a five to ten degree list to port. The *coup de grace* was delivered by a 1,760-pound bomb which slammed through her deck, igniting her forward ammunition magazine. The explosion of ammunition and fuel demolished the forward section of the vessel, which collapsed inside the hull.

Artist's rendering of the wreck as it lays today

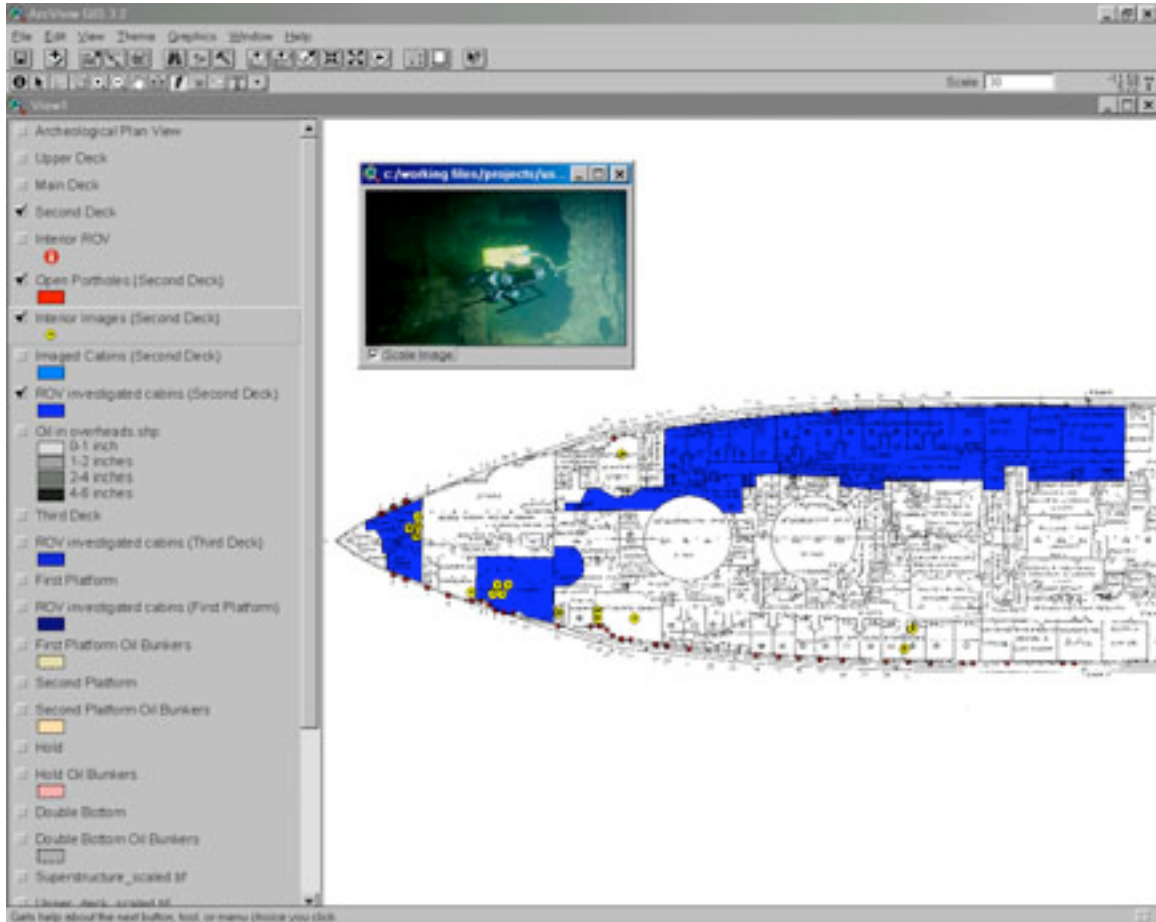
The wreck was found to be in an advanced state of deterioration at certain sections exposed to oxygenation yet surviving with paint intact in other sections of the wreck. VideoRay was able to provide to the National Park Service valuable previously inaccessible data to allow for an objective and scientific determination of the status of the wreck.
